THE CALIFORNIA EARTHQUAKE OF APRIL 18, 1906

STATE EARTHQUAKE INVESTIGATION COMMISSION

VOLUME I, PART II

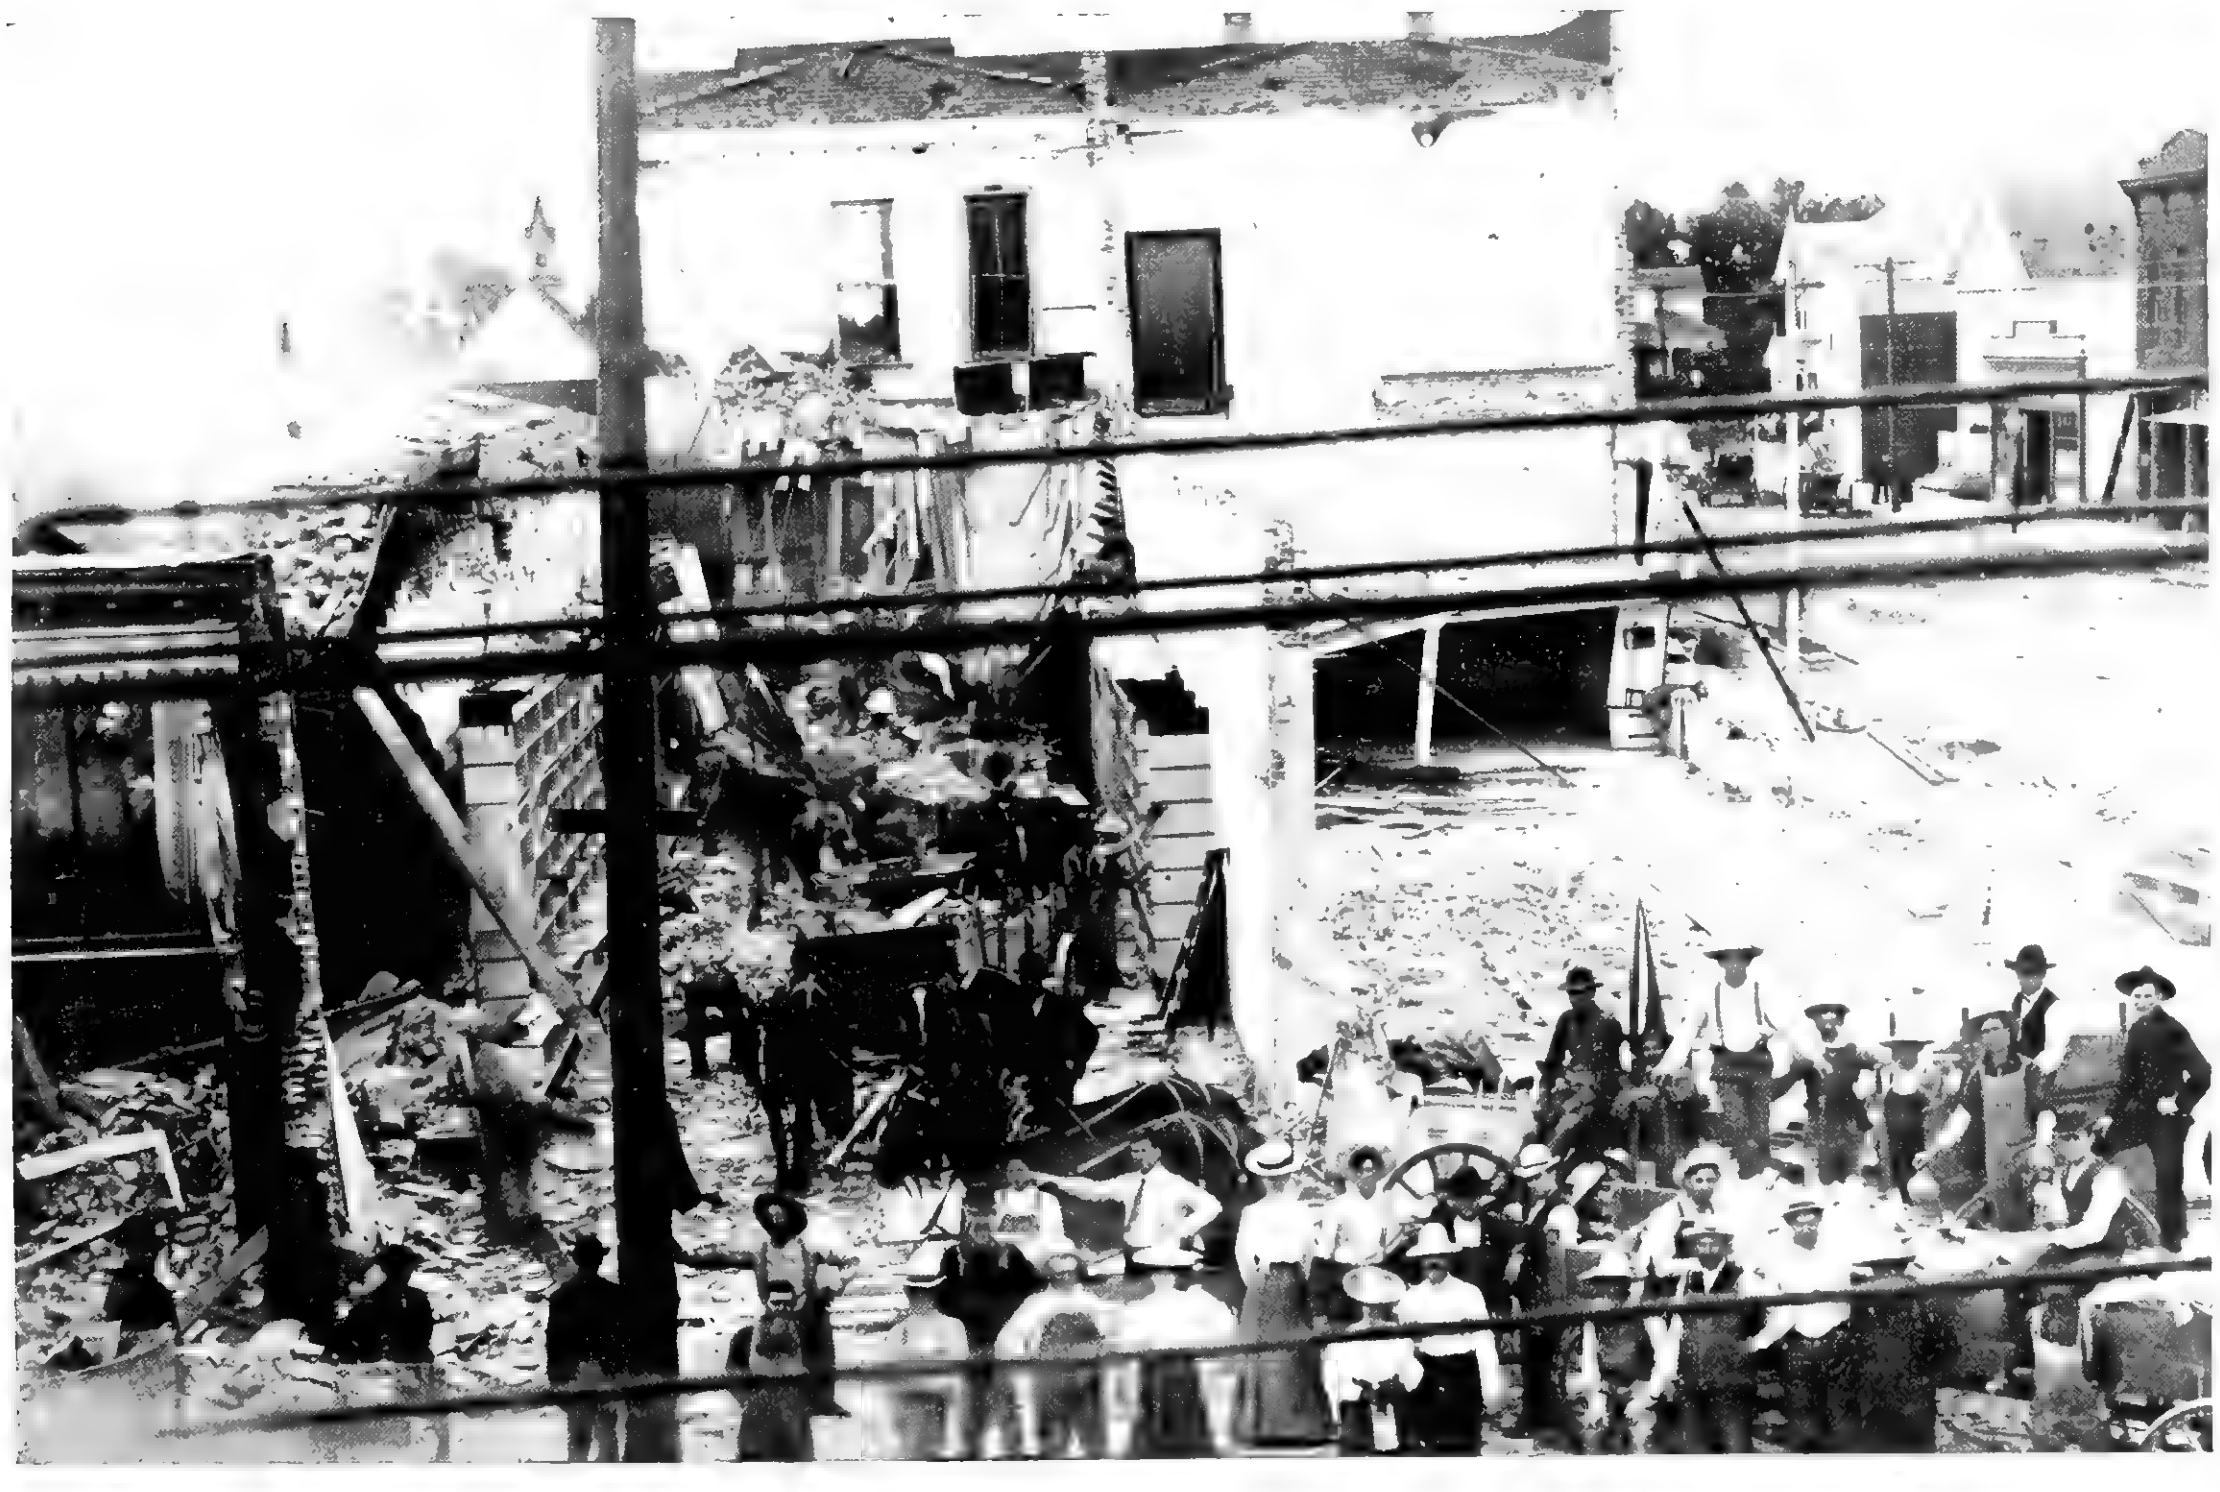
A. Alvarado. Wreck of molasses tanks, Alameda Sugar Company. E. W. B.

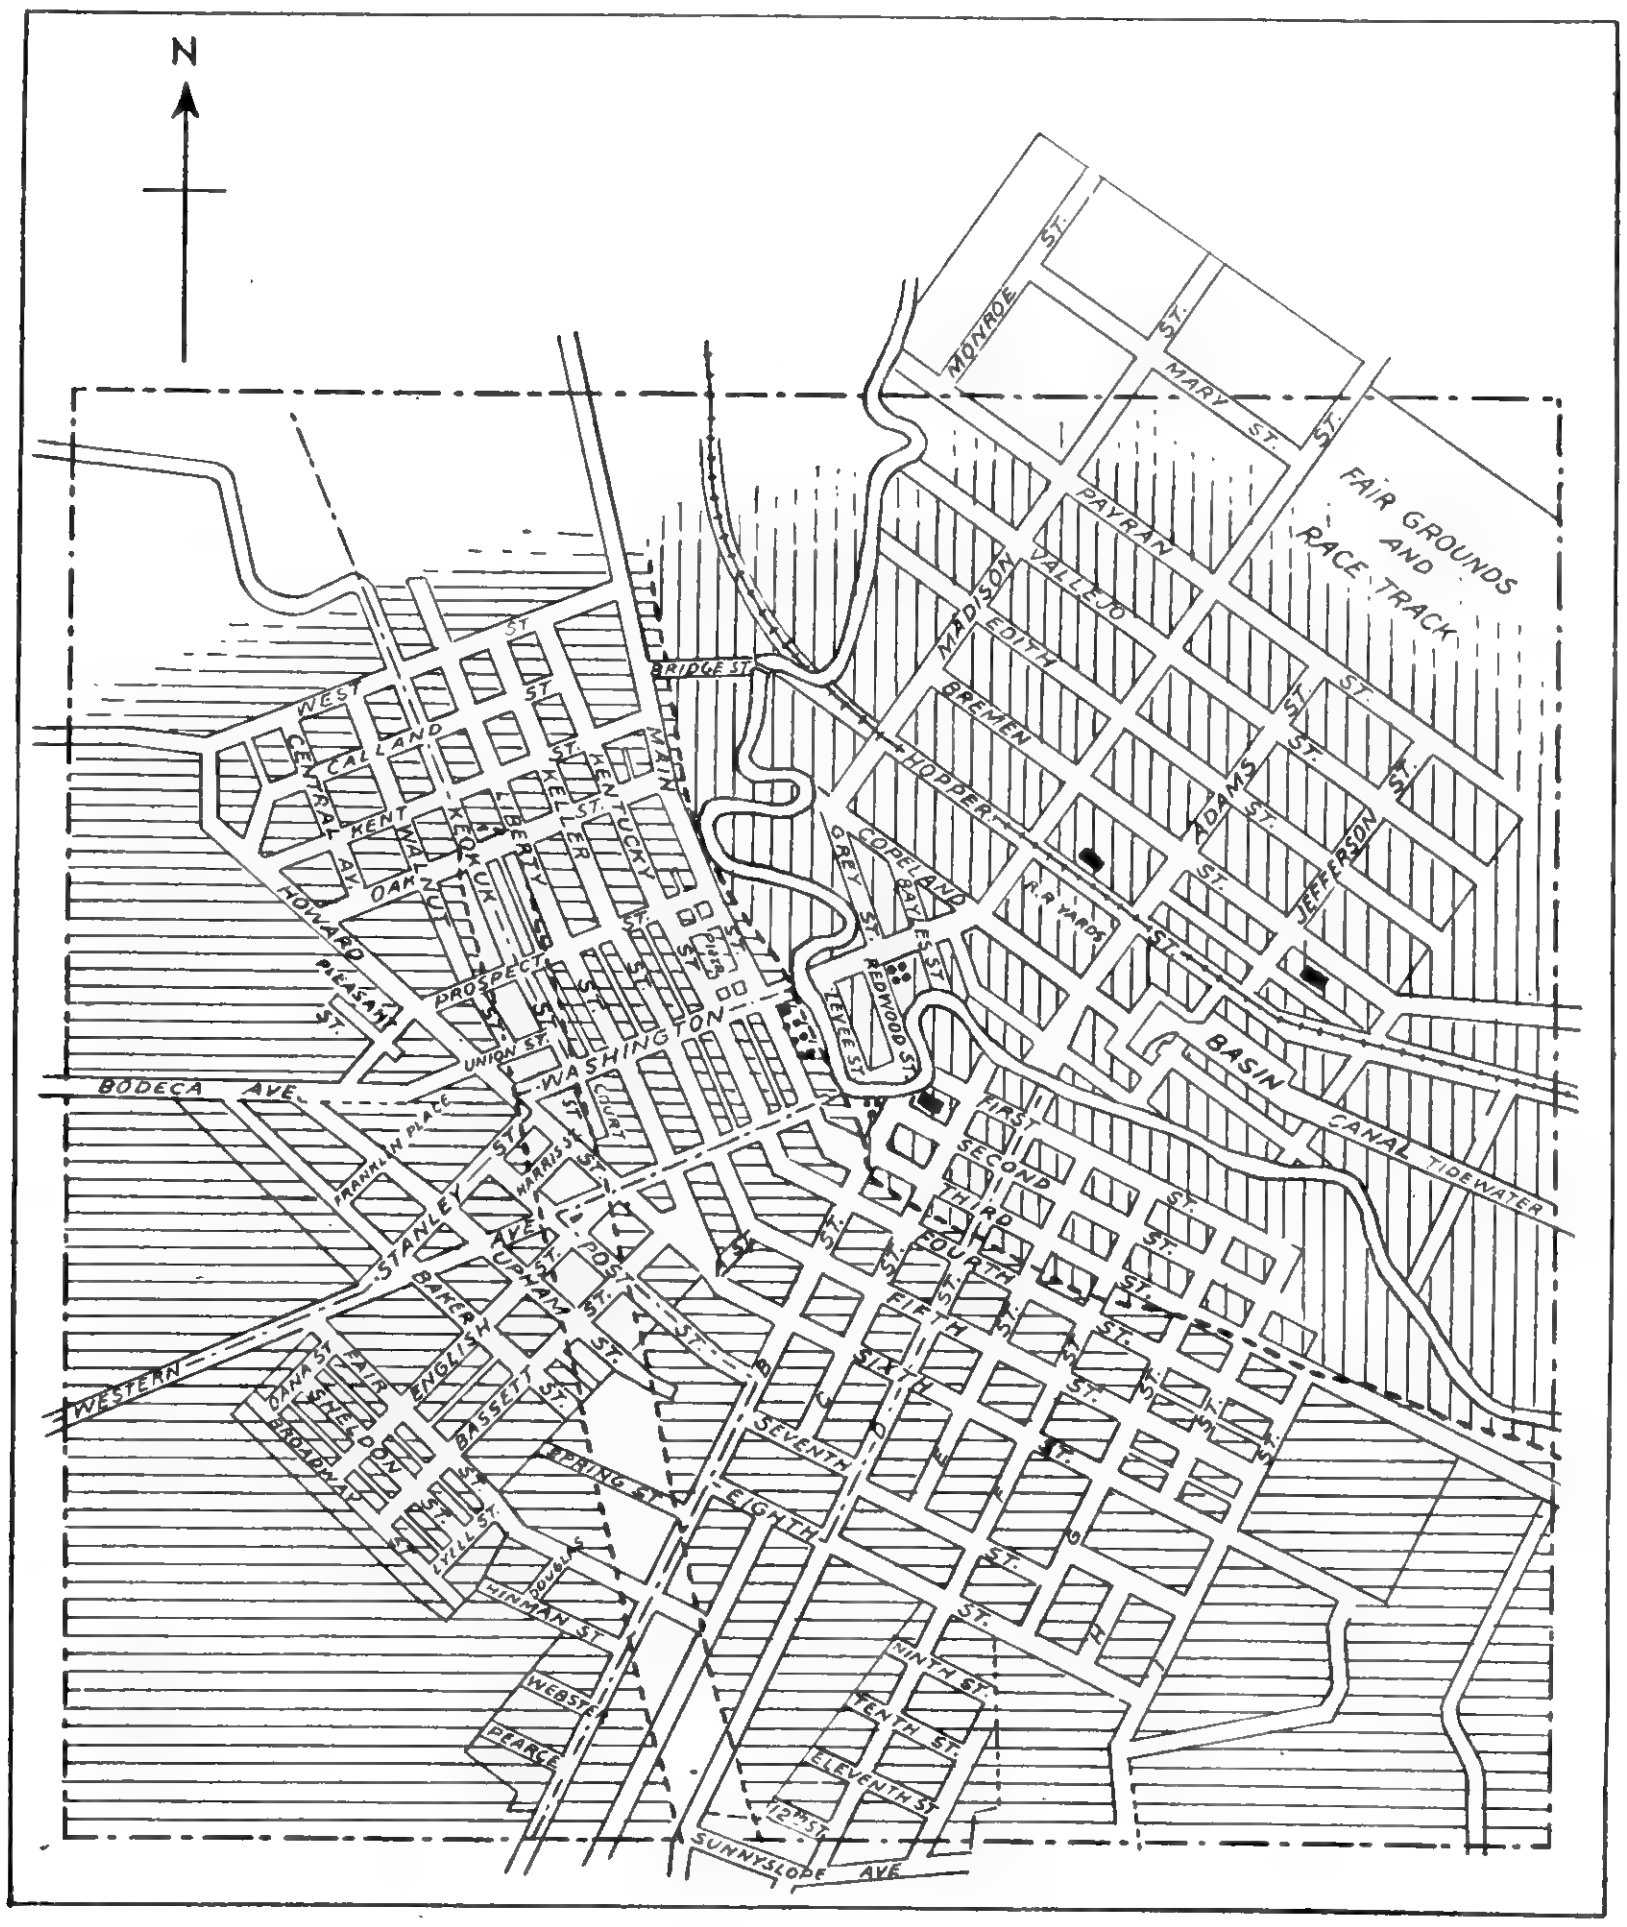
FIG. 64.—Distribution of intensity in Petaluma. Vertical lines represent area of low alluvial land, on which nearly all chimneys were damaged. Horizontal lines represent slopes underlain by rock, on which about half the chimneys were damaged. The solid black areas and dots represent exceptionally severe damage. The blank area inclosed by dotted lines represents a belt of practically no damage. By R. S. Holway.

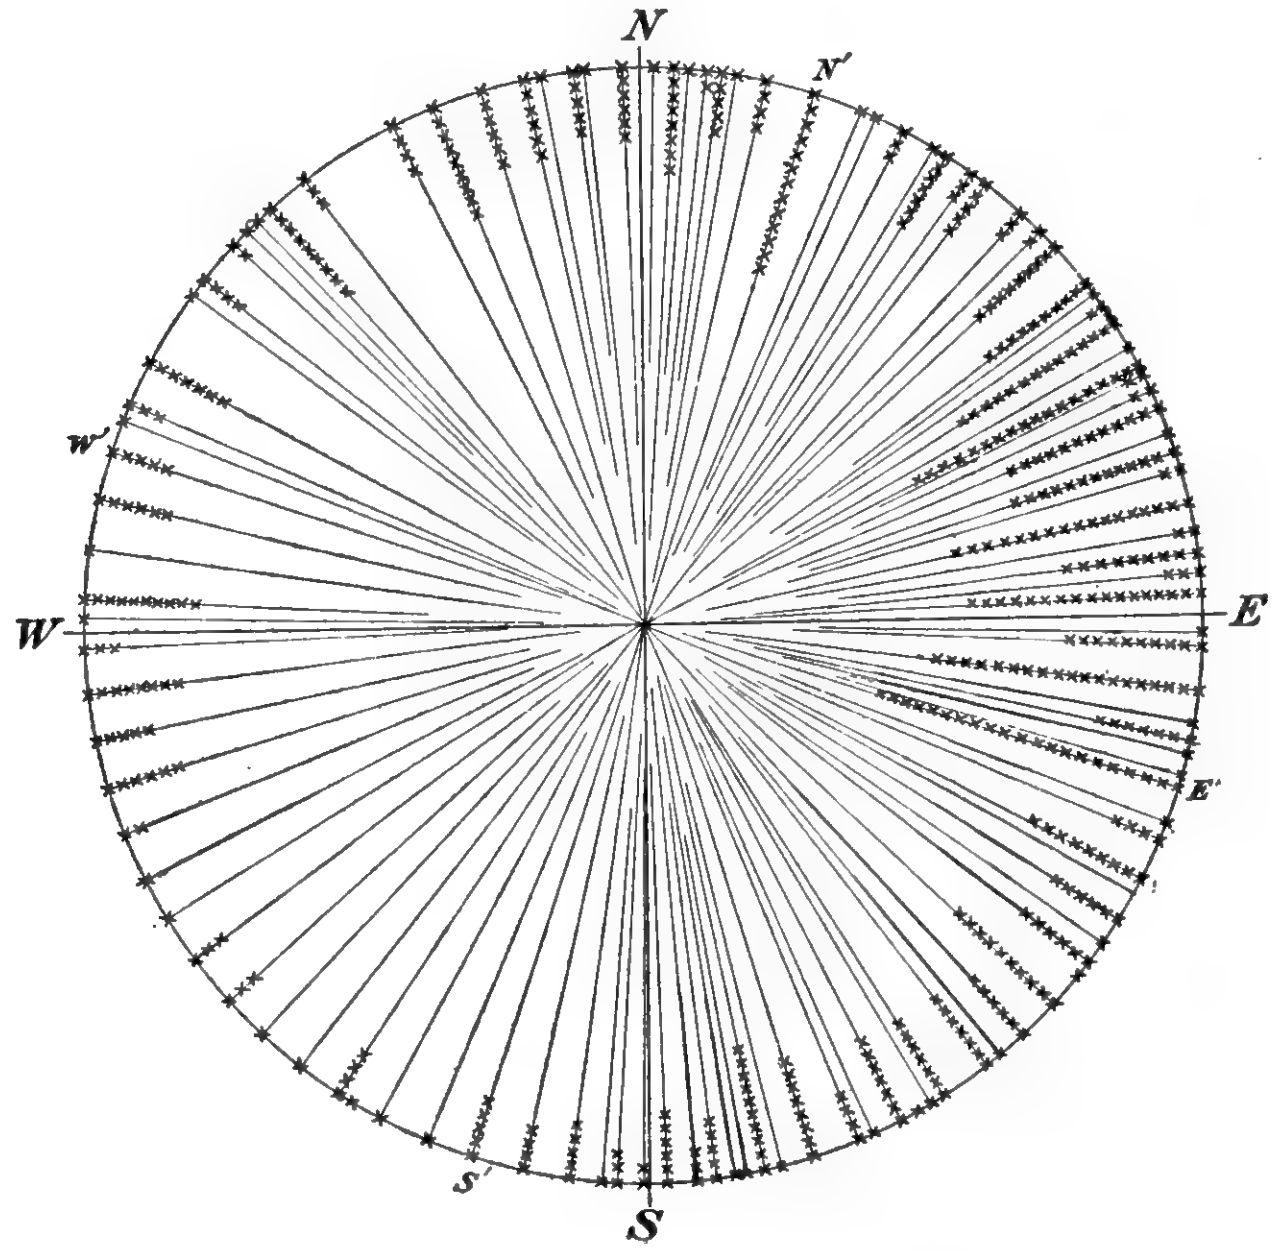
FIG. 66. — Statistical representation of the directions of fall of monuments in the cemeteries south of San Francisco. Each x represents a monument which fell in the direction indicated by the radius on which the x is placed. After Omori.

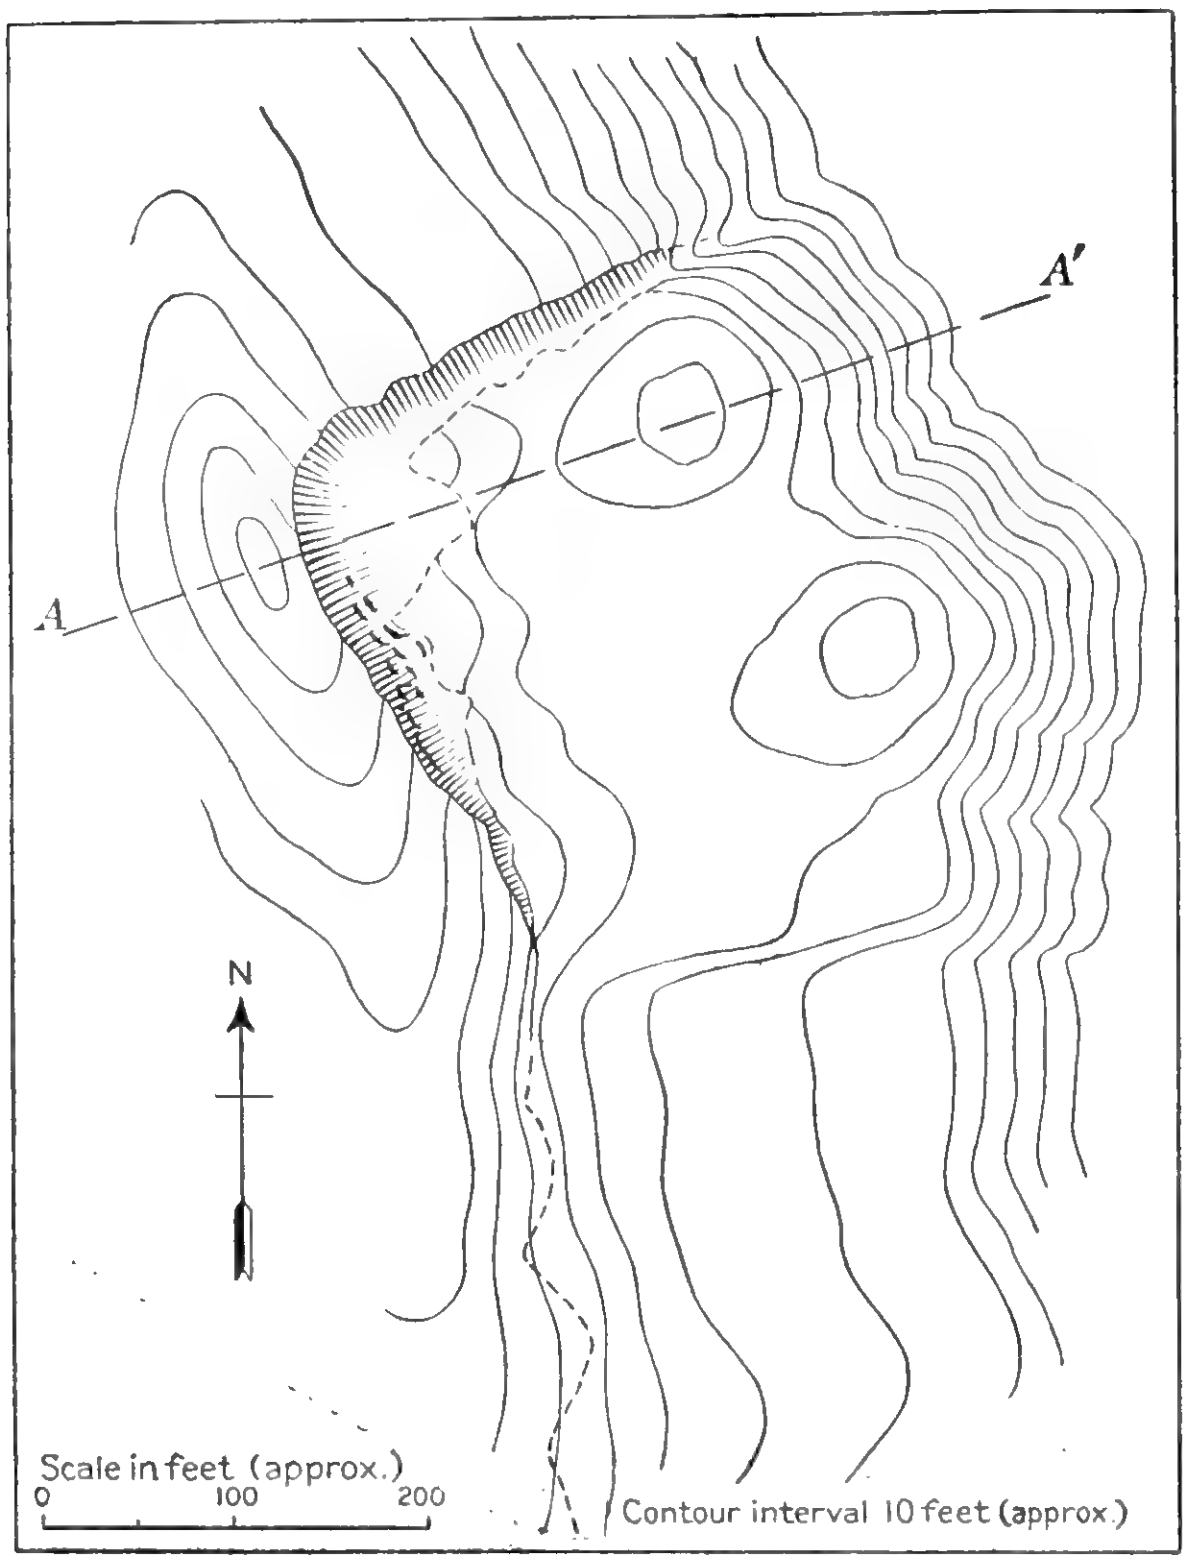
Fig. 68.—Map of landslide caused by the earthquake east of San Pablo.

A steep scarp has been produced east of the crest of the ridge. The downslip along this scarp does not exceed 50 feet, and decreases both to north and south. Along the north edge there has been a marked movement down and southward, the scarp there averaging 10 feet. Along the south side, on the other hand, the loosened mass had advanced over the old surface, presenting a bulging and cracked frontal scarp some 6 feet high. It appears from this that the movement took place, not along the line of greatest declivity, but in a direction somewhat more southward, as indicated by the arrow. The 2 hummocks probably existed before the slip occurred, but judging by their greatly cracked and rent surfaces, it seems likely that their height has been slightly increased. The main crack, which extends southward from the upper scarp, continues along the hillside in irregular zig-zags for some 300 feet south of the slide. (See plate 128A, B.)

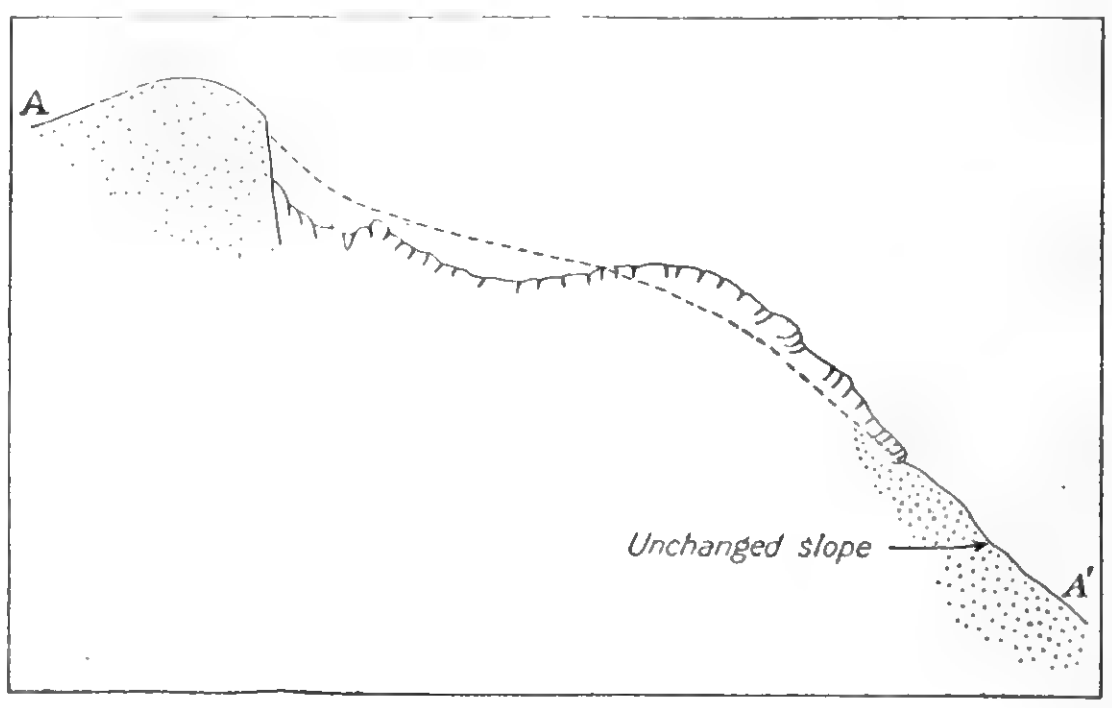
Fig. 69.—Section of landslide shown in fig. 68, along the line A–A'.

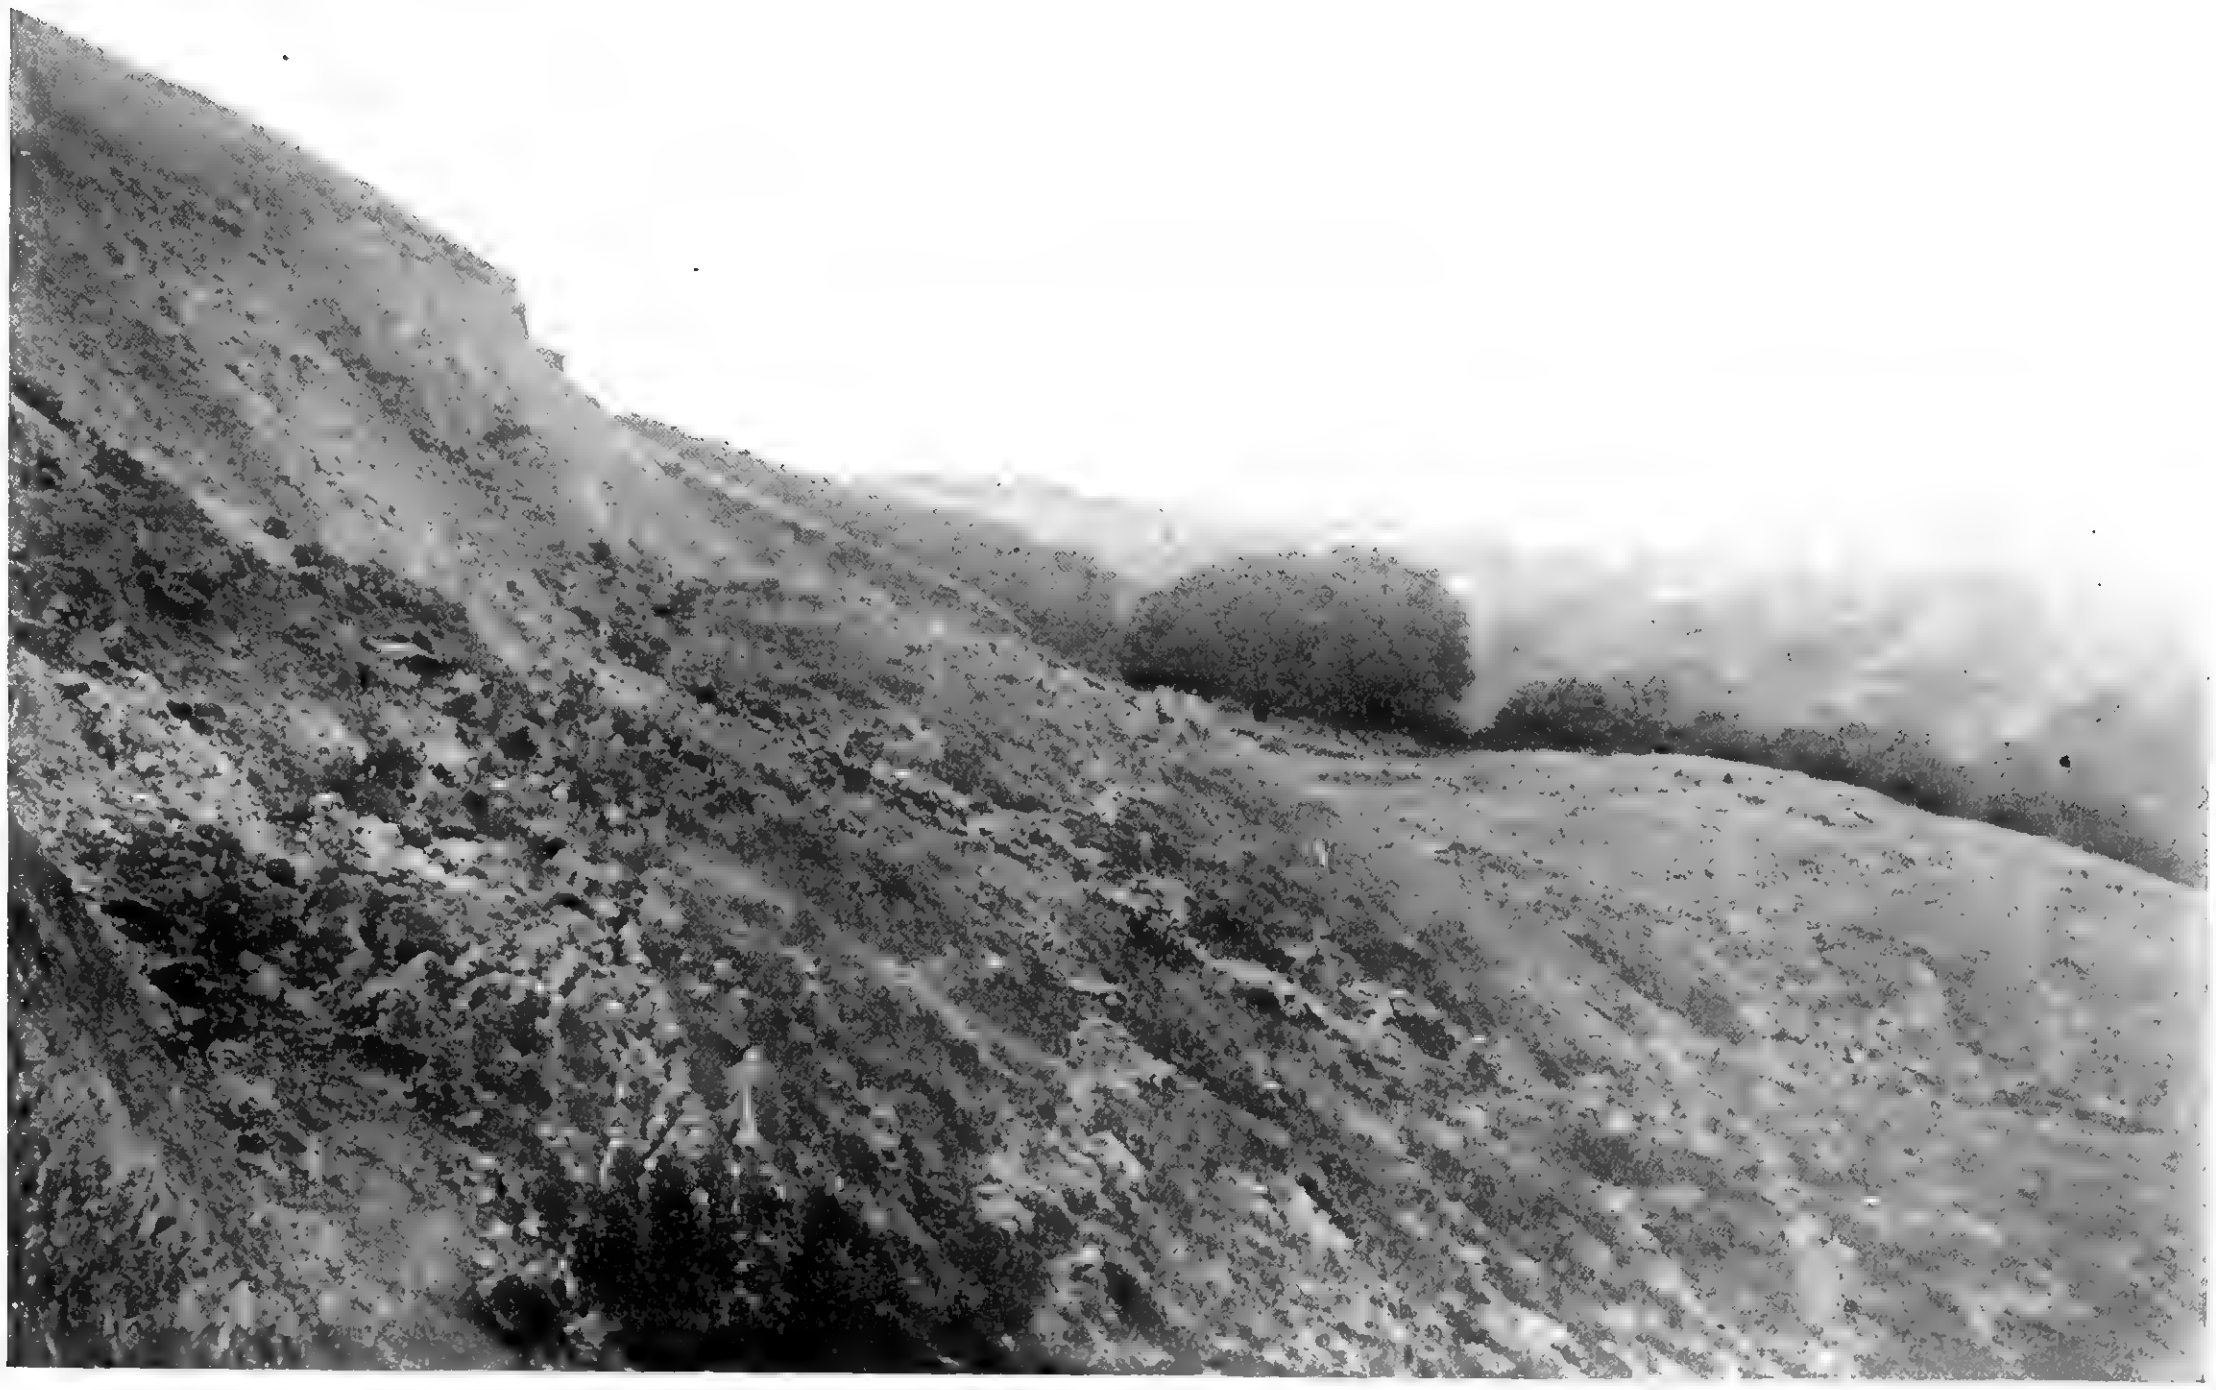
A. Earth-slump east of San Pablo. F. E. M.

B. Earth-slump east of San Pablo. F. E. M.

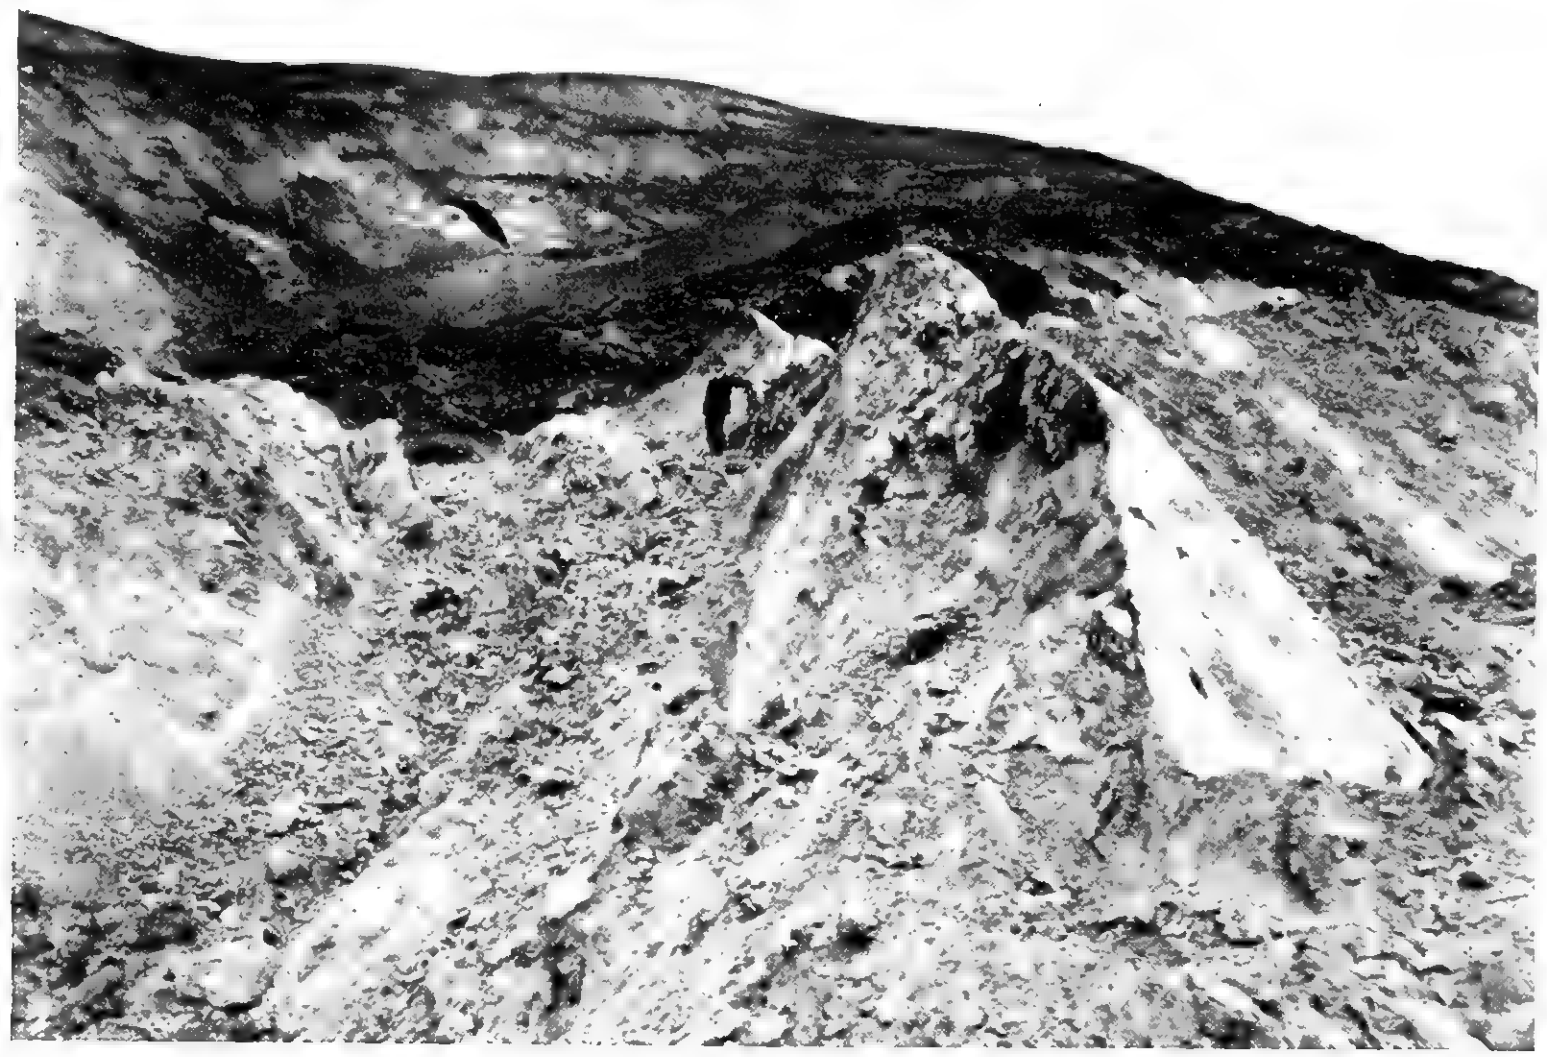
C. Earth-slump at Mussel Rock. Old slide suddenly accelerated by earthquake. C.

D. Scarp of Mussel Rock earth-slump. C.

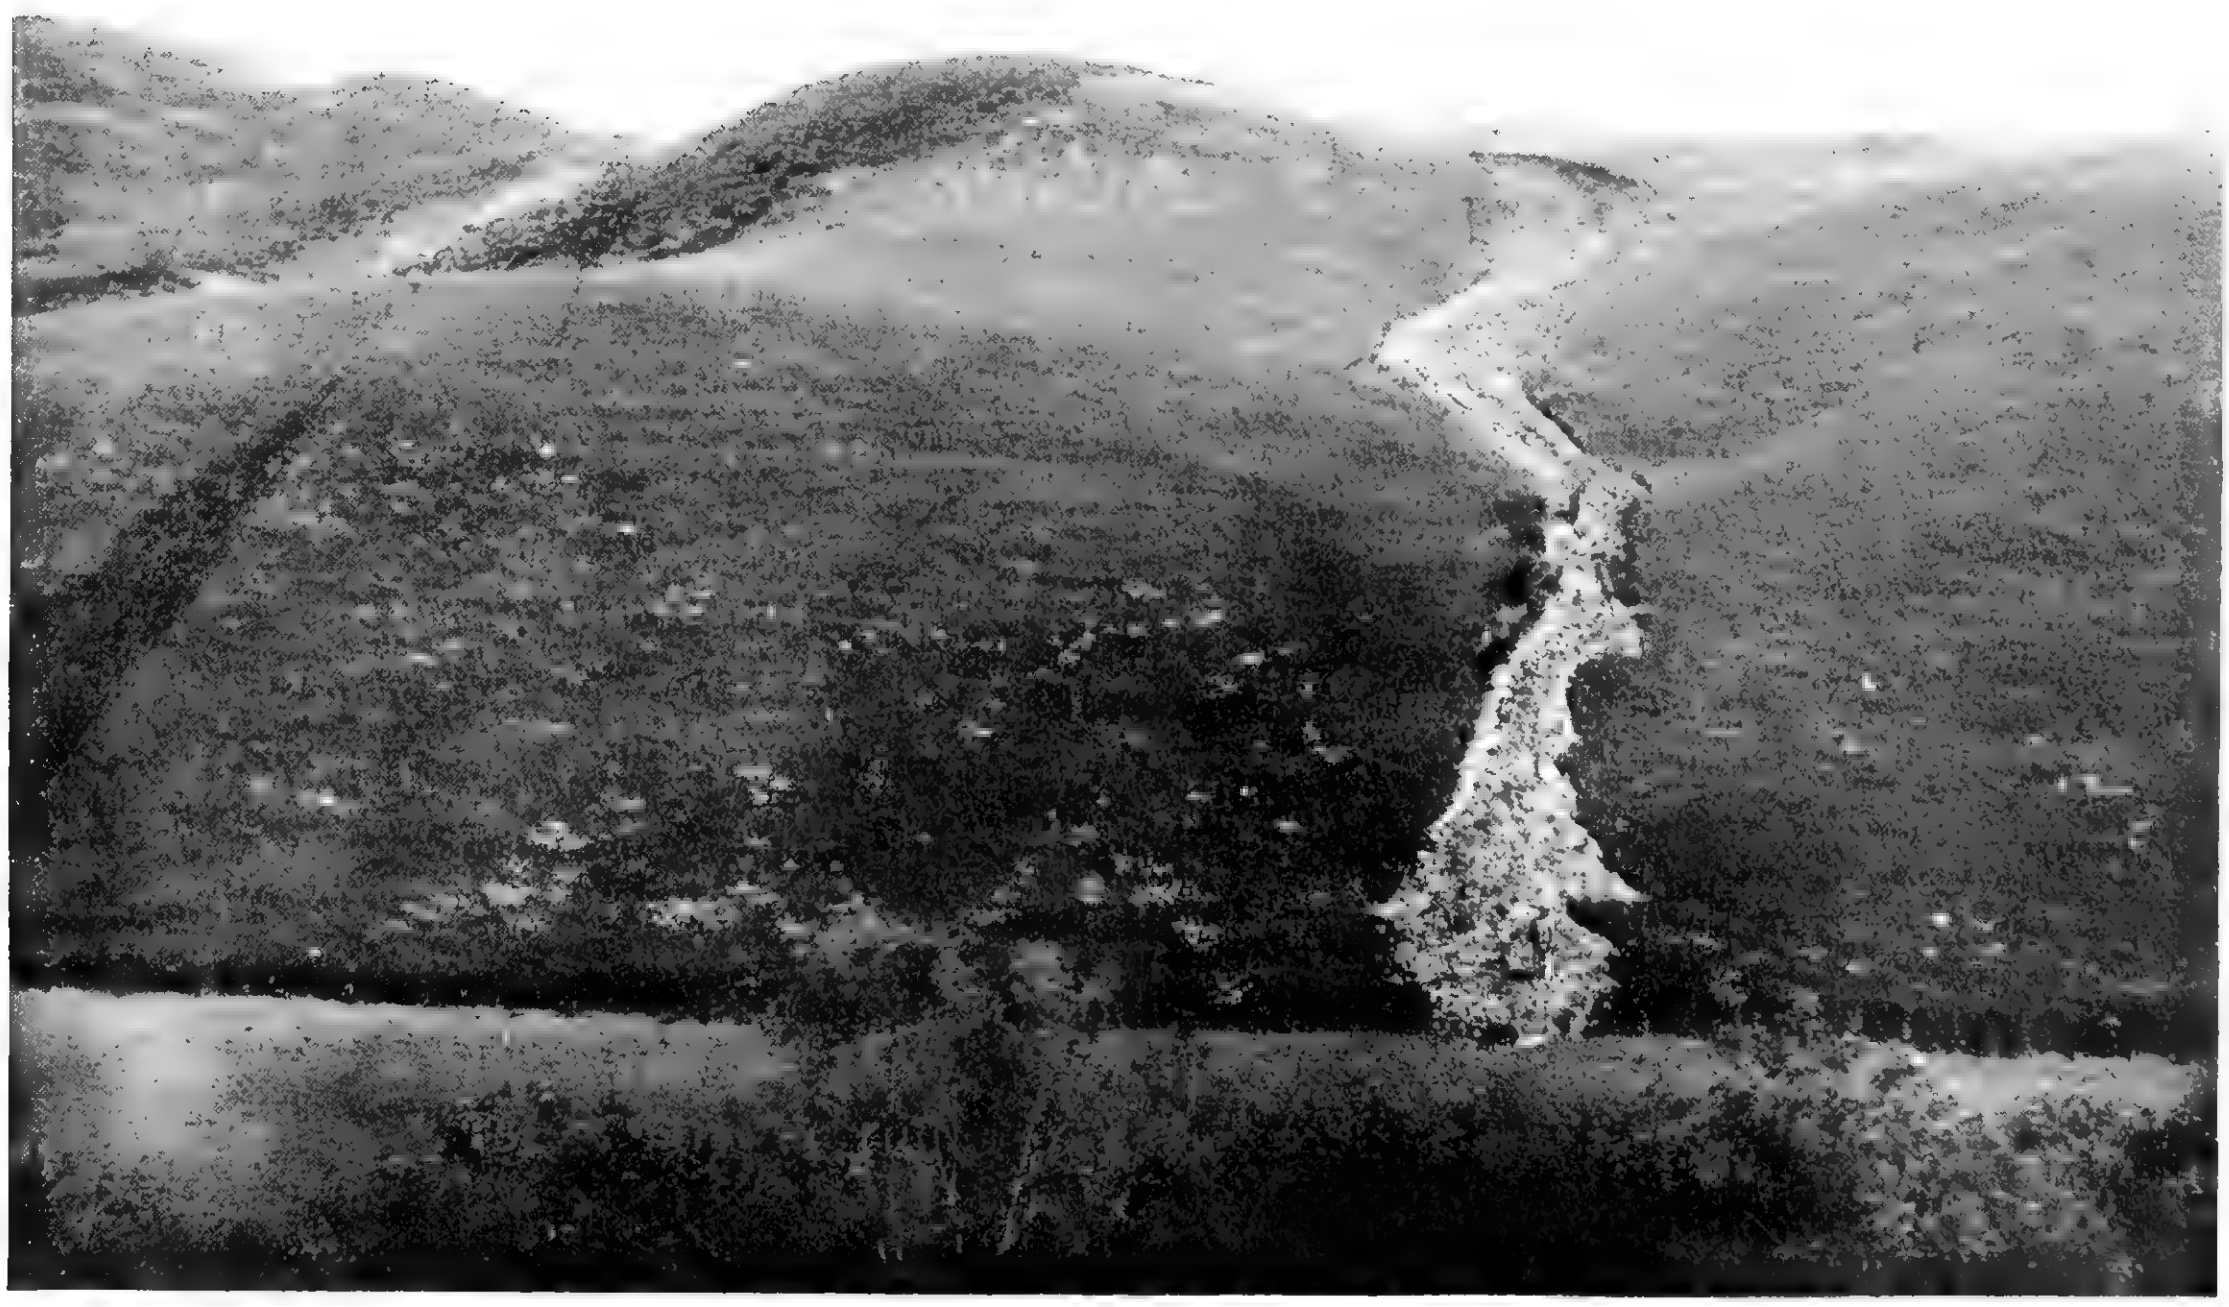
A. Earth-flow shown in Plate 132 B, illustrating floor of cavity from which flow came. R. A.

B. Earth-flow 4 miles east of Half Moon Bay. R. A.

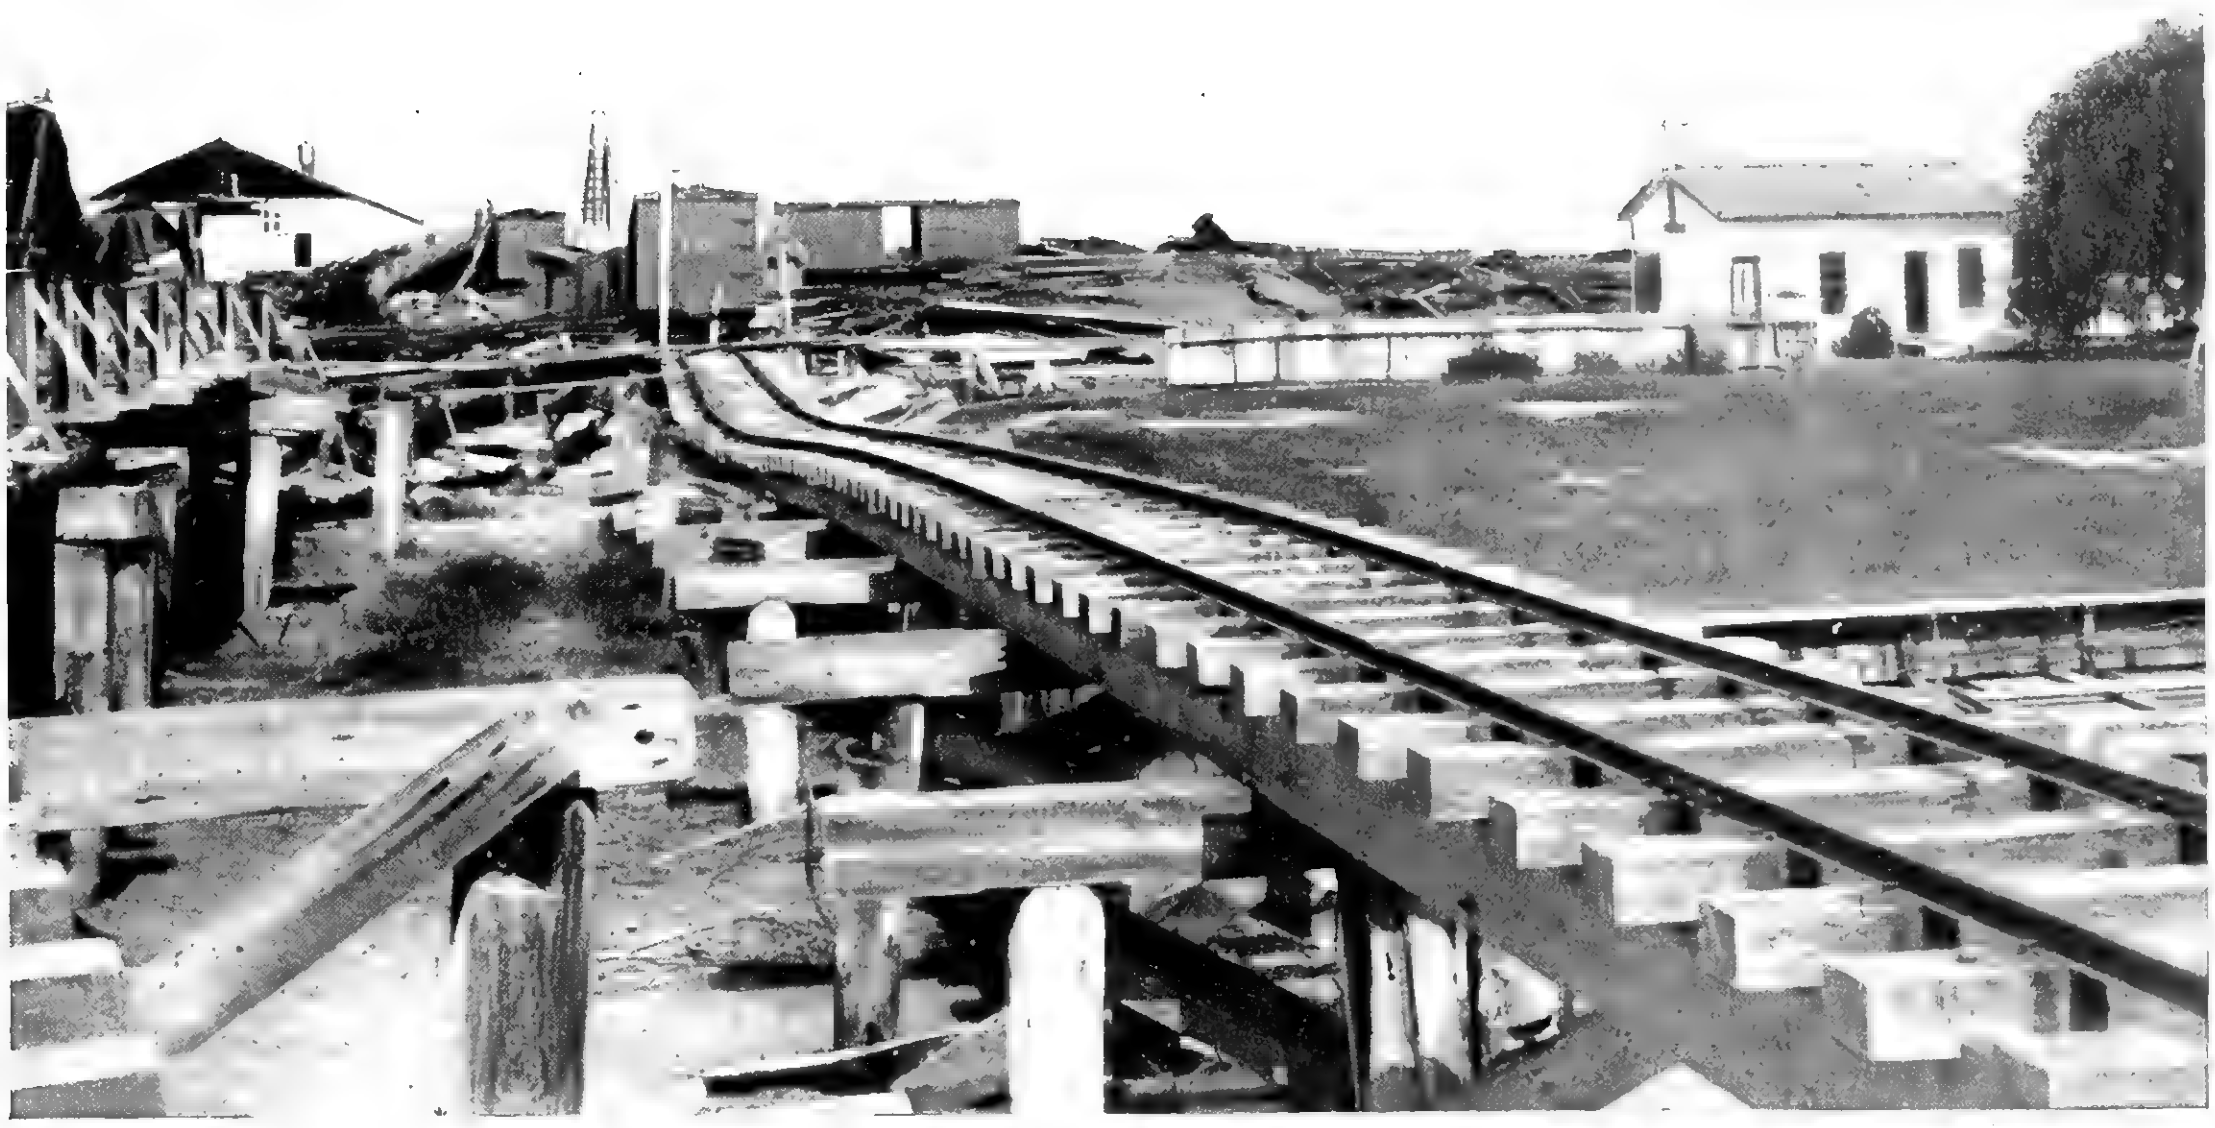
A. Moss Landing. House, tree, and fence moved 12 feet by lurching of ground toward Salinas River. A. C. L.

B. Moss Landing. Lurching of ground toward Salinas River carried piles from beneath bridge timbers, causing it to collapse. A. C. L.
